EXTERIOR CONDENSATION PROBLEMS

ProTek-USA

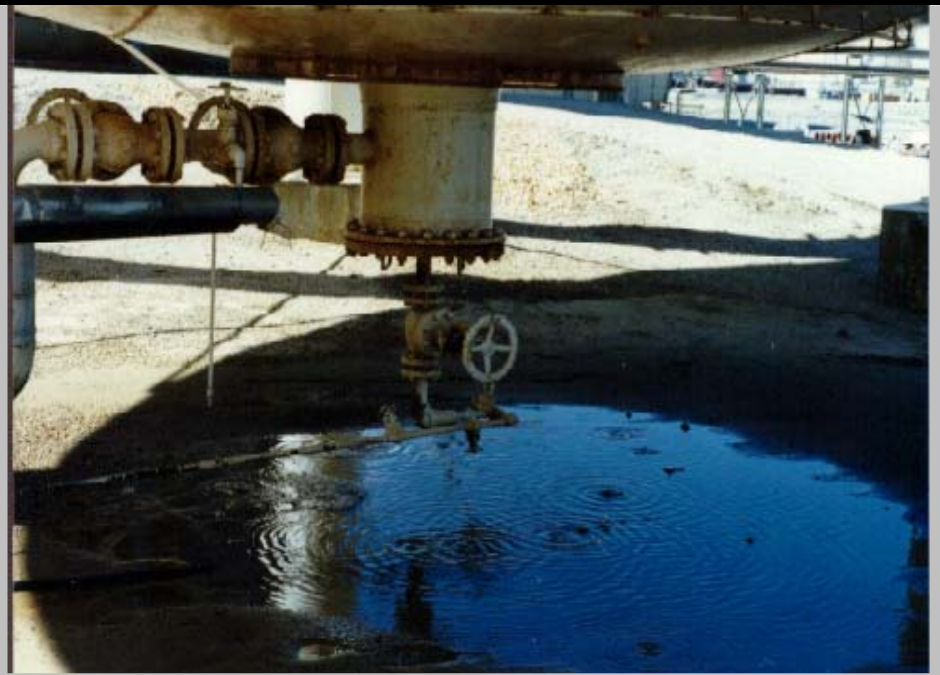
PROBLEM

- HIGH SURFACE TEMPERATURE
- EXCESSIVE, UNDESIRABLE INTERIOR PRESSURE DUE TO RADIANT AND CONDUCTED HEAT
- HIGH CONDENSATION AND CONSEQUENT CORROSION
- DRIPPING AND DAMAGE OF VALVE SYSTEMS AND CONTROLLERS
- SURFACE DETERIORATION THEREFOR, REDUCED LIFE OF THE SYSTEM
- EXPENSIVE SAND BLASTING LABOR COSTS TO RECOAT AND HIGH MAINTENANCE COSTS
- HIGH ENERGY REQUIREMENTS TO STABILIZE SYSTEM

THE REGULAR HIGH-QUALITY INDUSTRIAL WHITE ENAMEL THAT WAS USED TO PAINT THIS SPHERICAL TANK IS EXPERIENCING VERY POOR ADHESION, THE RESULT IS EXTREMELY HIGH CONDENSATION AND CONSEQUENT DETERIORATION AND CORROSION.

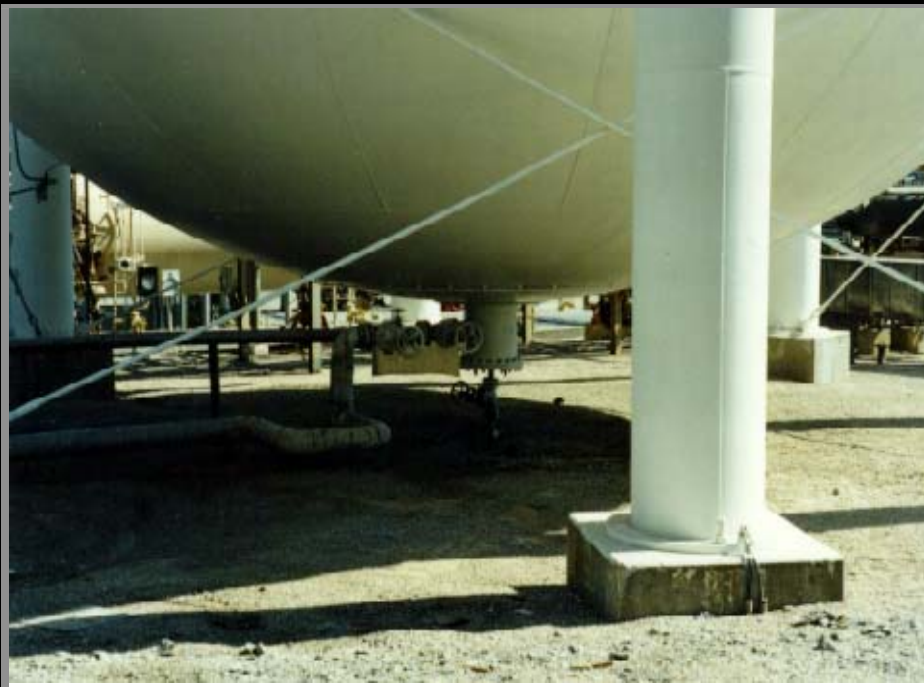
SOLUTION

THIS IDENTICAL SPHERICAL TANK WAS COATED WITH PROTEK-RUSTCOTE™, A ONE-PART POLYURETHANE, AS A PRIMER AND PROTEK-THERMCOTE/F™, A WATER-BASED CERAMIC ELASTOMERIC, THIS SYSTEM BONDS DIRECTLY TO THE SURFACE, CREATING A TIGHT INSULATING SEAL AND CONTROLLING THE LOSS OF HEAT OR COLD THROUGH THE SURFACE

- COATS METAL SURFACE AND INSULATES IT FROM RADIATION AND CONDUCTION OF HEAT
- HELPS MAINTAIN SYSTEM PRESSURE AND TEMPERATURE, THEREBY DECREASING FATIGUE OF MATERIALS AND PROLONGING THE LIFE OF EQUIPMENT
- REDUCES ENERGY CONSUMPTION
- RESULTS IN EXCELLENT RELATION OF COST-TO-BENEFIT RATIO AS IT IS NOT NECESSARY IN MOST CASES, TO SHUT DOWN THE SYSTEM IN ORDER TO RE-COAT
- SHUT-DOWN FREQUENCY FOR REFURBISHING IS SUBSTANTIALLY REDUCED OR ELIMINATED
